Manhole Inspection Summary

Manhole # S04YY1016MH

Insp Date: **7/25/06 1:26 PM**

Location Address: **3819 MIDHEIGHTS RD**

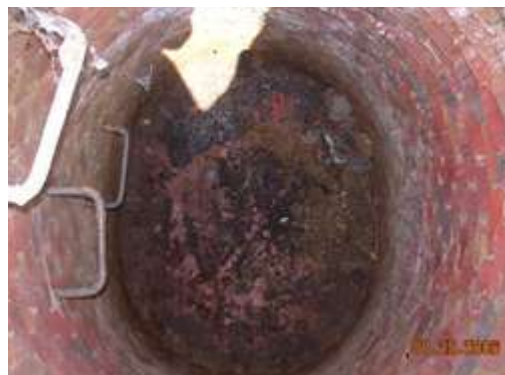
Top View

Adjustment and Barrel infiltration.
Evidence of surcharge - Channel debris.

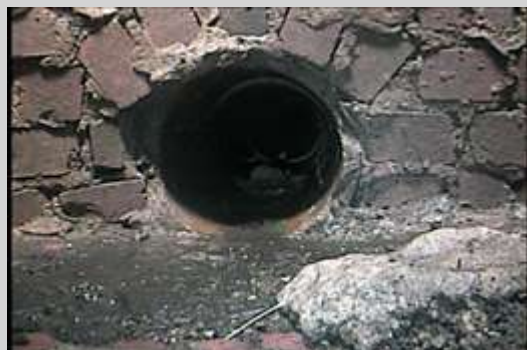
Pipe Out @ 12 O'Clock

Barrel deterioration and infiltration.

Pipe Seal Cond: **Broken**
